Report: Deficiency Report
Function: Test, Adjust, & Balance
Date: 05/23/2024

05-20-24 CARMAX #7110 - DORAL, FL

Issue List

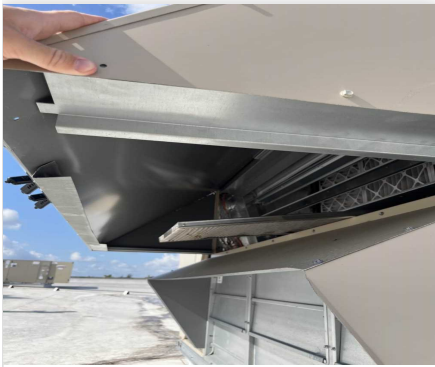
IMG_3058
05/22/2024

Issue Name : RTU 1 - OA Filters Incorrectly Installed
Description : The outside air filters were not correctly installed on RTU-1. All filters fell out of the unit and onto the rooftop when unit was tested in high speed.
Created By : National TAB **Assigned To :** National TAB - Stephen Tassinaro
Status : Open
Priority : High **Asset Tag :**
Originated Date : 05/22/2024 - Stephen Tassinaro - National TAB
