National TAB
1329 E. KEMPER ROAD
SUITE 4210
CINCINNATI, OH 45246

Report: FINAL TAB REPORT
Function: Test, Adjust, & Balance
Date: 7/12/2022

PROJECT
06-20 CULVERS - HARTFORD, WI

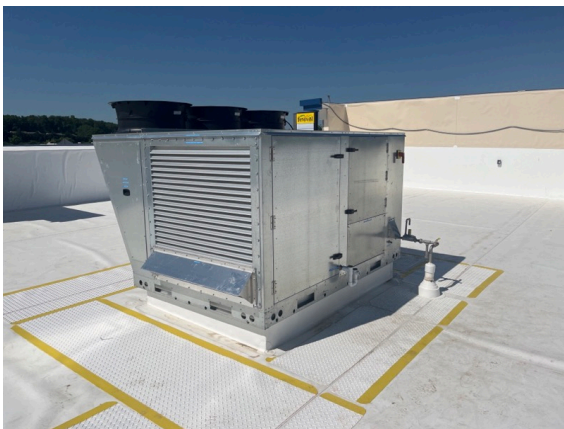
RTU-1

Notes:[1] TAKEN FROM VFD [2] HIGH STATIC PRESSURE. VERIFIED DUCTWORK CONFORMS TO PLANS AND ALL RETURN DAMPERS ARE OPEN. [3] RECOMMEND LARGER P-TRAP ON CONDENSATE DRAIN DUE TO HIGH STATIC PRESSURE.

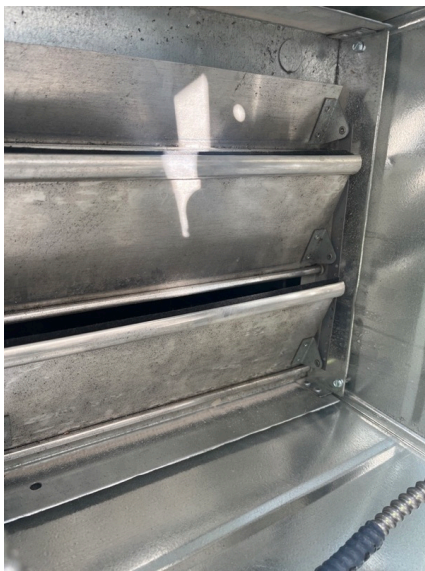
PRV-1
Backdraft damper installed and able
To move freely.
