**Report: PRELIM TAB REPORT
Function: Test, Adjust, & Balance
Date: 06/15/2023**

**PROJECT
06-19-23 CULVERS - COLUMBUS, GA**

Issue List

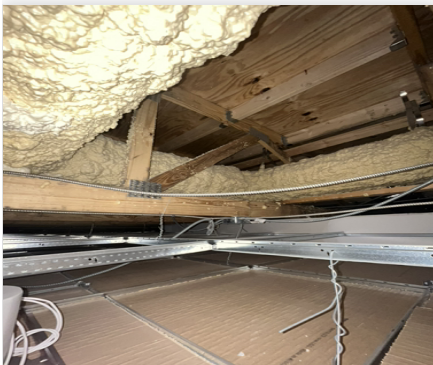
SprayFoamInsulation.j..
06/21/2023

Issue Name : INCORRECT DAMPERS INSTALLED
Description : MSET CALLS FOR VOLUME DAMPERS AT SUPPLY TAKEOFFS, INSTEAD DAMPERS WERE INSTALLED AT FACES OF DIFFUSERS. SEE MSET M201 DETAIL C6. EXISTENCE OF BRANCH DAMPERS COULD NOT BE VERIFIED DUE TO SPRAY FOAM INSULATION ON DUCT. THE FACE DAMPERS CAUSE EXCESSIVE NOISE AT SEVERAL DIFFUSERS.

- **06/22/2023 National TAB - William Patton**
 - RECOMMENDED TO INSTALL VOLUME DAMPERS FOR THE DIFFUSERS AT THE TAKEOFFS. IT IS ALSO RECOMMENDED TO INSTALL BRANCH DAMPERS. NTAB WAS UNABLE TO SEE OR USE ANY BRANCH DAMPERS DUE TO SPRAY INSULATION ON THE DUCTWORK.

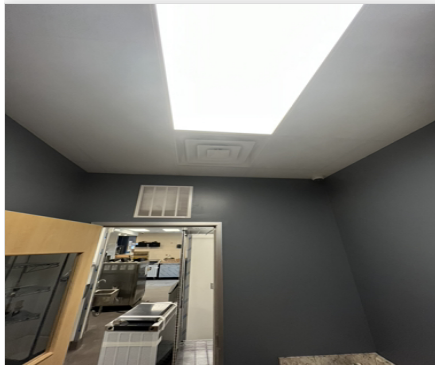
OfficeDiffuser
06/21/2023

Issue Name : OFFICE DIFFUSER DUCTWORK
Description : OFFICE SUPPLY DIFFUSER IS DUCTED TO RTU2 INSTEAD OF RTU1. MSET M101 CALLS FOR THAT DIFFUSER TO BE DUCTED TO TO RTU1. PER MECHANICAL THE TRUSS WORK MAKES DUCTING TO RTU1 IMPOSSIBLE. THIS MAY LEAD TO UNCOMFORTABLE TEMPERATURES IN OFFICE AS THE KITCHEN CALLS HAS A DEMAND FOR COOLING WIEN THE OFFICE IS ALREADY COLD.

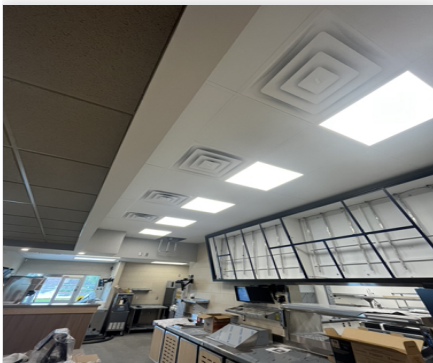
LowLineDiffusers
06/21/2023

Description : AS A RESULT OF INCORRECT DAMPERS BEING INSTALLED AND THE DUCTWORK LAYOUT DIFFERING FROM THAT SHOWN ON THE MSET THERE ARE 4 DIFFUSERS THAT ARE BELOW DESIGN. SEVERAL FULL PASSES WERE MADE TO ATTEMPT TO RESOLVE THIS BUT WERE UNSUCCESSFUL. SPACE IS COMFORTABLE AS IS.

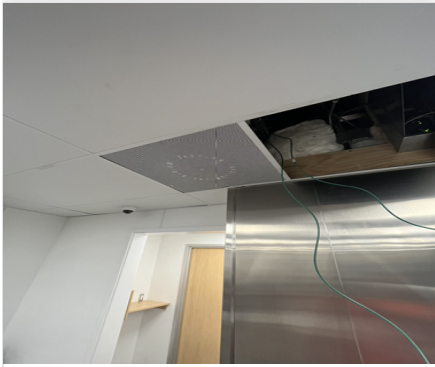
SGRD8
06/21/2023

Issue Name : RTU2 & RESTROOM EXHAUST MISSING DAMPERS
Description : BACK OF HOUSE IS MISSING 8 DAMPERS. ALL RESTROOM EXHAUST DIFFUSERS ARE MISSING DAMPERS.
Created By : National TAB **Assigned To :** National TAB - William Patton
Status : Closed
Originated Date : 06/21/2023 - William Patton - National TAB

- **06/21/2023 National TAB - William Patton**
 - MECHANICAL CONTRACTOR INSTALLED MISSING DAMPERS.
