**Report: TAB Report**  
**Function: Test, Adjust, & Balance**  
**Date: 12/05/2025**  
**Completed By: National TAB**

## 12-01-25 APPLEBEES PEMBROKE PINES, FL

Flynn Restaurant Group  
6200 Oak Tree Boulevard  
Suite 250  
Independence, OH 44131

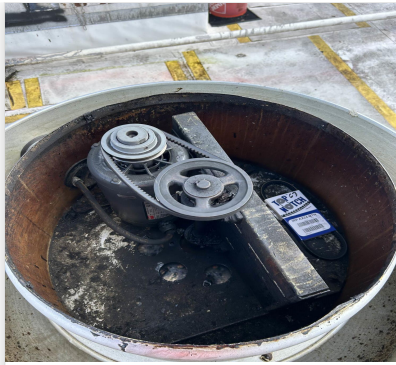
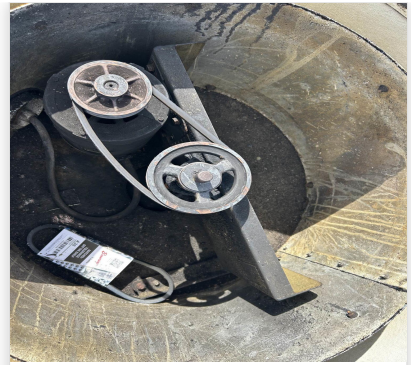
**Inside of motor compartment**

Pulleys rusted

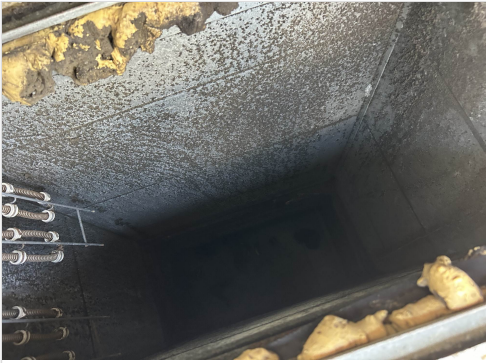
[1] Damper is broken in half, OA is fully open on one side as a result.

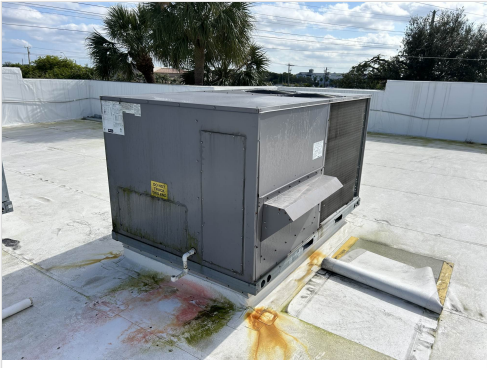
[1] A negligible amount of outside air is present due to damage to OA damper (very small gap at top-right corner). Cannot be accurately measured on the roof.
