**Report: Test Report**  
**Function: Test, Adjust, & Balance**  
**Date: 11/19/2025**  
**Completed By: National TAB**

**09-01-25 BOJANGLES #1264 MARIETTA, GA**

Budderfly

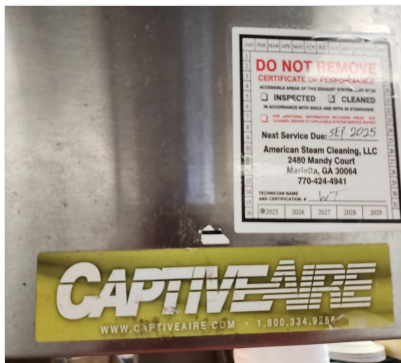
# Label Faded
