Report: TAB Survey
Function: Test, Adjust, & Balance
Date: 10/13/2025
Completed By: National TAB

**10-06-25 BOJANGLES #1012 COLLEGE
PARK, GA**

Budderfly

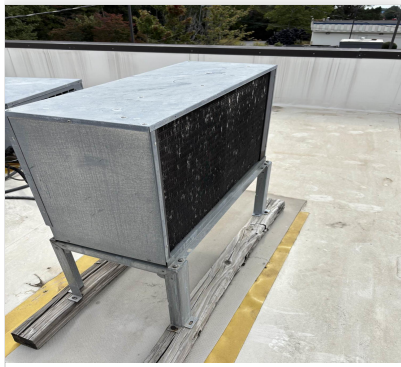
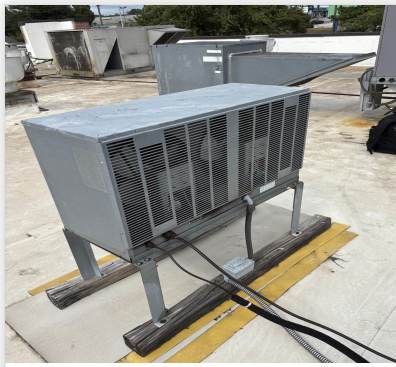
Picture of condenser

Issue Name : CONDENSERS 4 AND 5 DAMAGED FINS
Description : Condensers 4 and 5 have damage to external fins. Replacing is recommended.
Created By : National TAB **Assigned To :** National TAB - Will Turnbough
Status : Open
Priority : Medium **Asset Tag :**
Originated Date : 10/07/2025 - Sagar Patel - National TAB

Is the condenser free of damage? Note any concerns

Fail

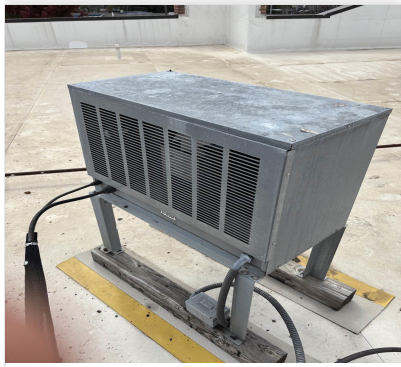
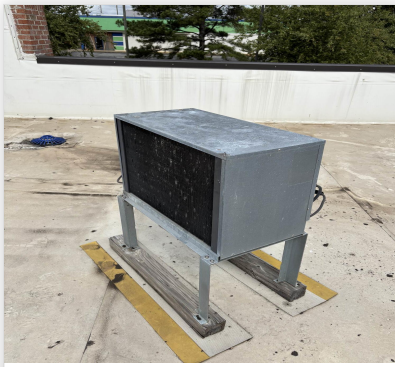
Picture of condenser

Is the condenser free of damage? Note any concerns

Fail

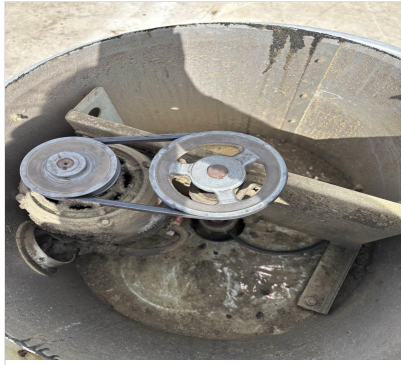
Inside of motor compartment

Issue Name : EF 1, 2, AND 3 DIRTY MOTOR COMPARTMENT
Description : The motor compartment is dirty in Exhaust Fans 1, 2, and 3. Cleaning is recommended.
Created By : National TAB **Assigned To :** National TAB - Will Turnbough
Status : Open
Priority : High **Asset Tag :**
Originated Date : 10/07/2025 - Sagar Patel - National TAB

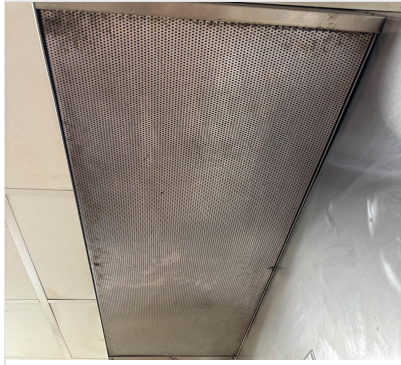
MUA plenum

Is the MUA discharge plenum clean and not clogged? If there is a PSP shine a light into the perforated metal and see if the top layer appears to be clogged Fail

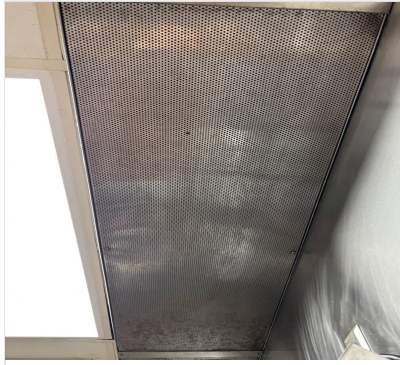
MUA plenum

Is the MUA discharge plenum clean and not clogged? If there is a PSP shine a light into the perforated metal and see if the top layer appears to be clogged Fail

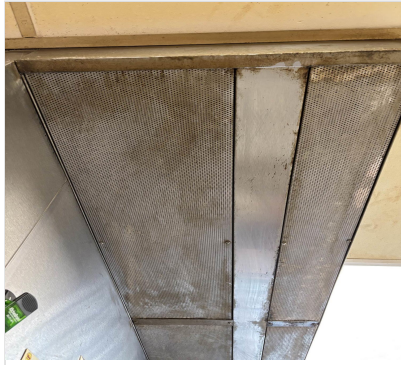
MUA plenum

Is the MUA discharge plenum clean and not clogged? If there is a PSP shine a light into the perforated metal and see if the top layer appears to be clogged	Fail
---	------

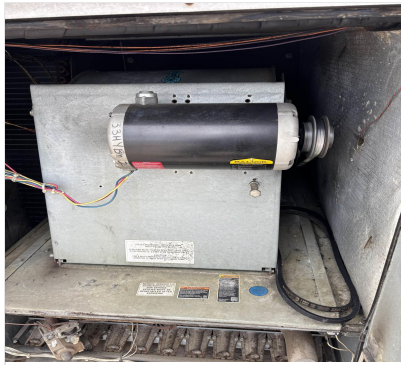
Blower compartment.

Fail
