## GSA DC0021ZZ Central Office Headquarters (Washington, DC)

**AHU Measurement NOVA Third Party Contractor Fill Out. Measure and verify the building minimum and maximum outdoor air for each AHU providing outdoor air to the building.**

**GSA\_HQ\_OAHU-S1**

**Monday, December 13, 2021**

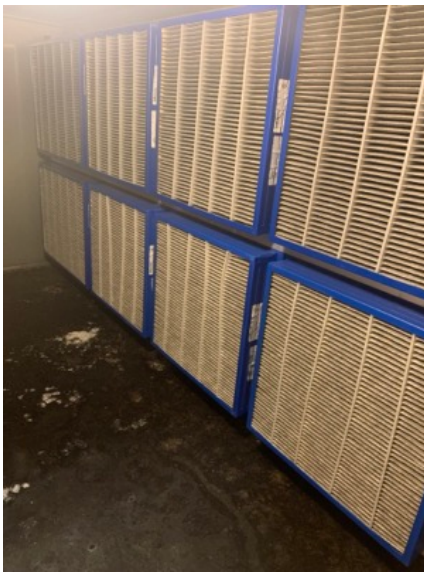
S1 pre-filters

Attach Photos of AHU Nameplate.	Yes
Pre-Filter MERV Rating (or NA)	The pre-filter MERV rating are MERV 8

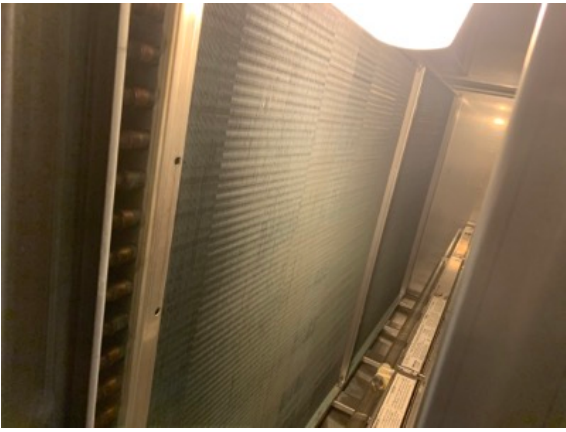
Cooling Coil(s) - Visual assessment and photo documentation.	BACK SIDE OF COOLING COIL 1 HAS OXIDATION. FRONT SIDE OF COOLING COIL 2 HAS SOME RUST ON THE FLOOR WHERE THE CONDENSATE PAN IS. BACK SIDE OF COIL 2 HAS BENT FINS
Condensate Pan(s) - Visual assessment and photo documentation.	CONDENSATE PAN IS FREE OF DEBRIS. THERE IS SOME RUST FORMING NEAR COOLING COIL 2
Any unusual operation observed? (including vibration, over-pressure, etc.)	THERE IS NO UNUSUAL OPERATION

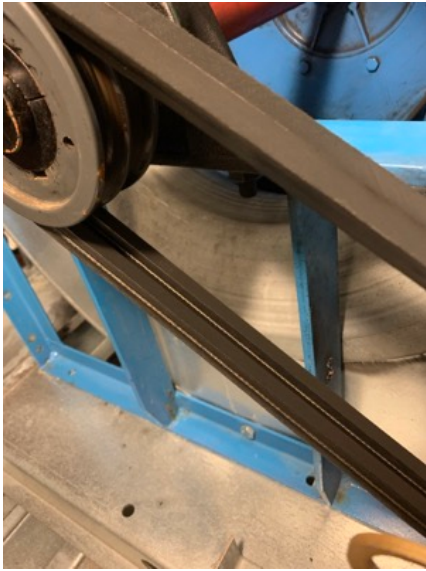
BELT CONDITION

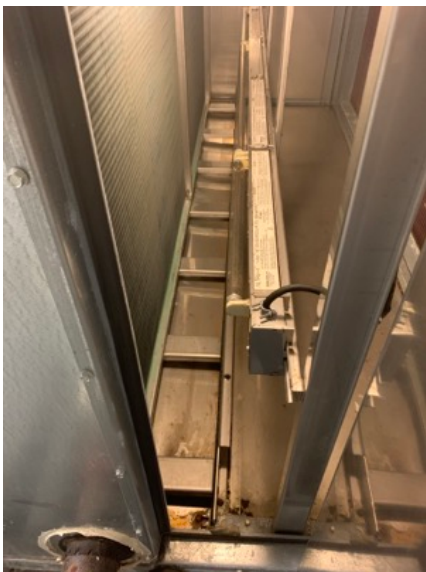
CONDENSATE DRAIN

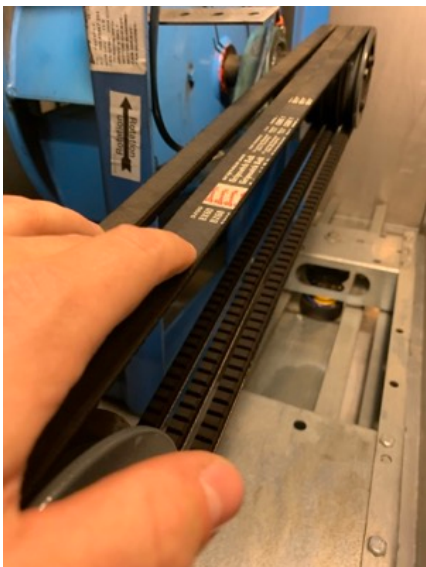
MIDDLE BELT IS BEIT TENSIONED PROPERLY

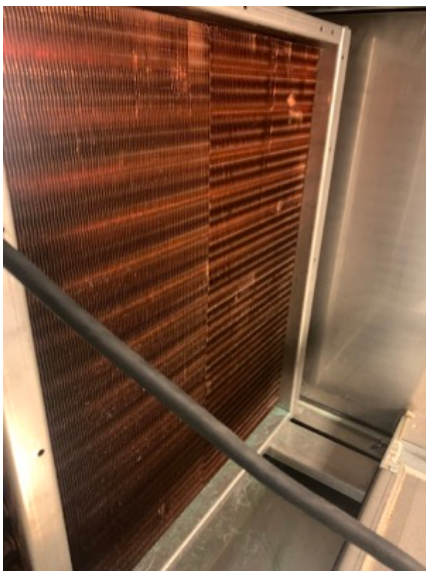
COOLING COIL

Pre-Filter MERV Rating (or NA)	3-MERV8 3-MERV10
Pre-Filter Size	3-20X24X2 3-24X24X2
Final Filter MERV Rating	3-MERV15 3-MERV14/14A
Final Filter Size	3-20X24X4 3-24X24X4
Belts - Visual Assessment of condition	BELTS ARE IN GOOD CONDITION, NO CRACKS, BELT TENSION IS GOOD
Belts - Size and quantity	2-B95R
Note if the AHU has full air side economizing ability & Damper Type.	NO ECONOMIZING CAPABILITIES. THERE IS A DAMPER ON THE RETURN AND ON THE OA. BUT IT IS NOT FOR THE PURPOSE OF ECONOMIZING SINCE OA IS SUPPLIED THROUGH A VAV
Note if any modifications made to AHU set points to operate in full capacity.	Static Set Point increased from 1.75" to 2.0 "
Electrical connections - Visual assessment. Document motor Voltage and Amperage.	CONNECTIONS ARE SECURED V-436 A-17.4A
Heating Coil(s) - Visual assessment and photo documentation.	HEATING COIL IS IN GOOD CONDITION
Cooling Coil(s) - Visual assessment and photo documentation.	FINS ON COOLING COIL ARE STRAIGHT. THERE IS SOME OXIDATION ON THE BACK SIDE OF THE COIL.

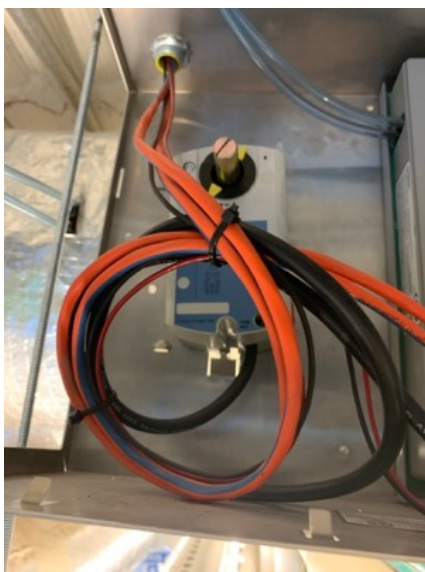
OA DAMPER POSITION

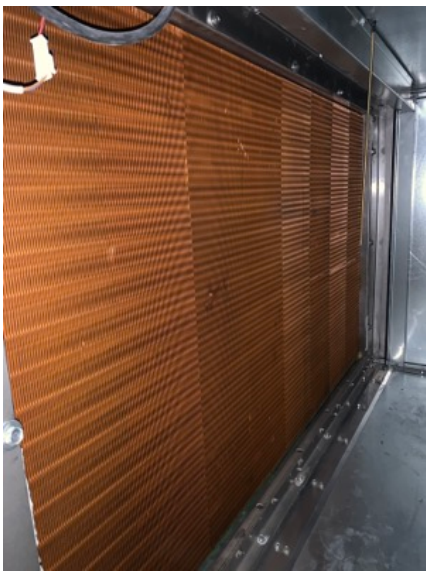
COOL COIL

Cooling Coil(s) - Visual assessment and photo documentation.	COOLING COIL IS IN GOOD CONDITION. THERE IS SOME OXIDATION ON THE INLET PIPE OF THE COIL
Condensate Pan(s) - Visual assessment and photo documentation.	CONDENSATE PAN IS FREE OF DEBRIS. THERE ARE SOME SIGNS OF OXIDATION COMING FROM THE COIL INLET
Any unusual operation observed? (including vibration, over-pressure, etc.)	THERE IS A SMALL PUNCTURE IN THE CANVAS CONNECTOR OF THE SUPPLY DUCT THAT IS CAUSING MINOR LEAKAGE
Exhaust System Status (on/off). If this does not apply for this AHU, "N/A"	N/A UNIT DOES NOT HAVE EXHAUST

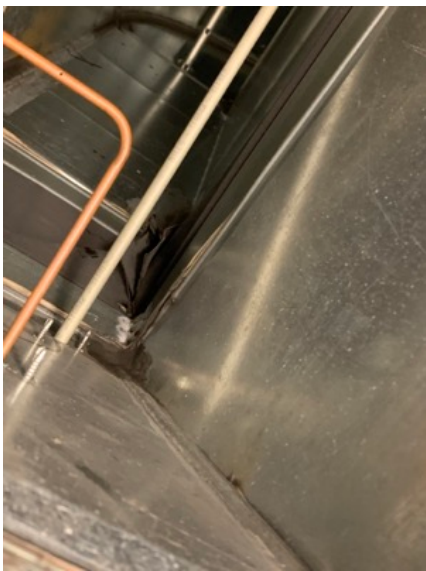
PUNCTURE IN CANVAS CONNECTOR-SUPPLY

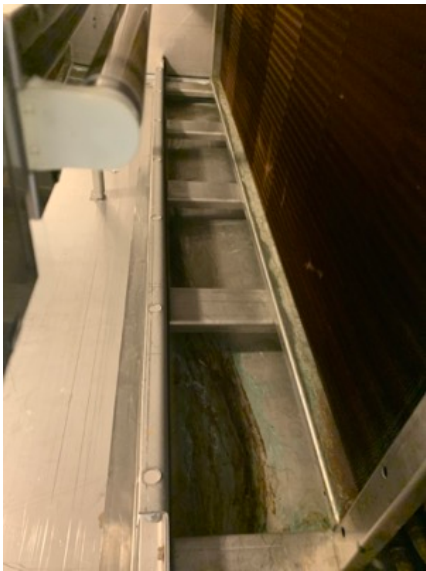
Pre-Filter MERV Rating (or NA)	FILTER DOES NOT LIST MERV RATING. LOOKS LIKE MERV-7 OR MERV-8
Pre-Filter Size	2-12X24X2 2-20X24X2
Final Filter MERV Rating	2-MERV14/14A 2-MERV15
Final Filter Size	2-12X24X4 2-20X24X4
Belts - Visual Assessment of condition	BELTS ARE IN GOOD CONDITION. NO CRACKING
Belts - Size and quantity	2-5VX630
Note if the AHU has full air side economizing ability & Damper Type.	OA comes from VAV.
Note if any modifications made to AHU set points to operate in full capacity.	NO SET-POINT CHANGES HAD TO BE MADE
Electrical connections - Visual assessment. Document motor Voltage and Amperage.	ELECTRICAL CONNECTIONS ARE GOOD VOLTS-460V AMPS-12.2
Heating Coil(s) - Visual assessment and photo documentation.	UNIT IS NOT EQUIPPED WITH HEATING COIL
Cooling Coil(s) - Visual assessment and photo documentation.	NO DAMAGED OR BENT FINS
Condensate Pan(s) - Visual assessment and photo documentation.	CONDENSATE PAN HAS SOME OXIDATION, BUT THERE IS NO DEBRIS IN THE PAN

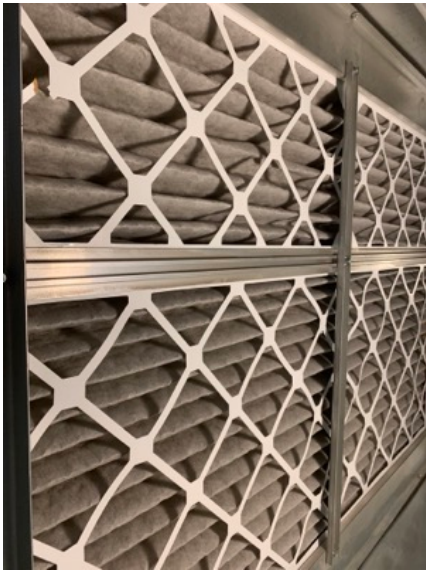
PREFILTER CONDITION

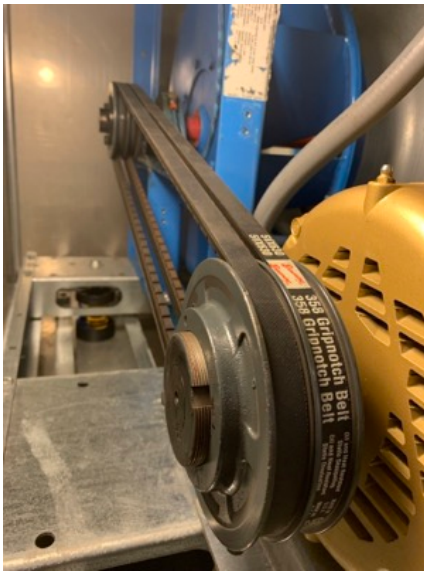
BELT CONDITION

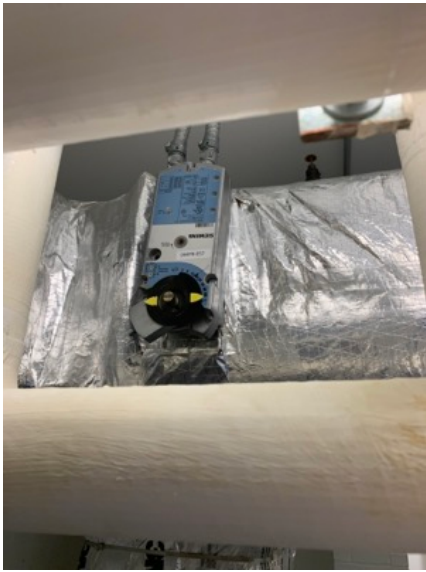
ZONE DAMPERS HAD TO BE MANUALLY OPENED SO UNIT WOULD REACH FULL SPEED. THE SPRING RETURN DOES NOT WORK ON ZONE DAMPERS THERE IS A DAMPER ON THE SIDE OF THE UNIT THAT IS FIXED CLOSED BUT COULD POTENTIALLY BE A FUTURE SOURCE OF RETURN LEAKAGE THERE IS A DAMPER INTERNAL TO THE RETURN IF THE UNIT THAT IS NOT MOTORIZED AND COULD BE A SOURCE OF LEAKAGE BACK SIDE OF COOLING COIL HAS A LOT OF OXIDATION FILTERS ARE DUE FOR A CHANGE. ONE OF THE BELTS IS STRETCHED AND SHOULD BE REPLACED.

ZONE DAMPERS HAD TO BE MANUALLY OPENED
